DEVELOPMENT OF A FIELD REPAIR TECHNIQUE FOR
'MINI-SANDWICH' KEVLAR/EPOXY AIRCRAFT SKIN(U) NAVAL
POSTGRADUATE SCHOOL MONTEREY CA D B CRIPPS JUN 84

THESIS

DEVELOPMENT OF A FIELD REPAIR TECHNIQUE
FOR "MINI-SANDWICH" HETAL/EPoxy
AIRCRAFT SKIN

20. ABSTRACT (Continue on reverse side if necessary and identify by block number) An experimental analysis was performed on Kevlar/epoxy cloth "mini-sandwich" panels with cellular foam core. Three undamaged panels and twenty-three other panels with damage and repairs were subjected to static shear loading. Four parameters were varied in the types of repairs; hole size, hole plug filler material, patch material, and patch overlap distance. All twenty-six panels were tested to failure. A

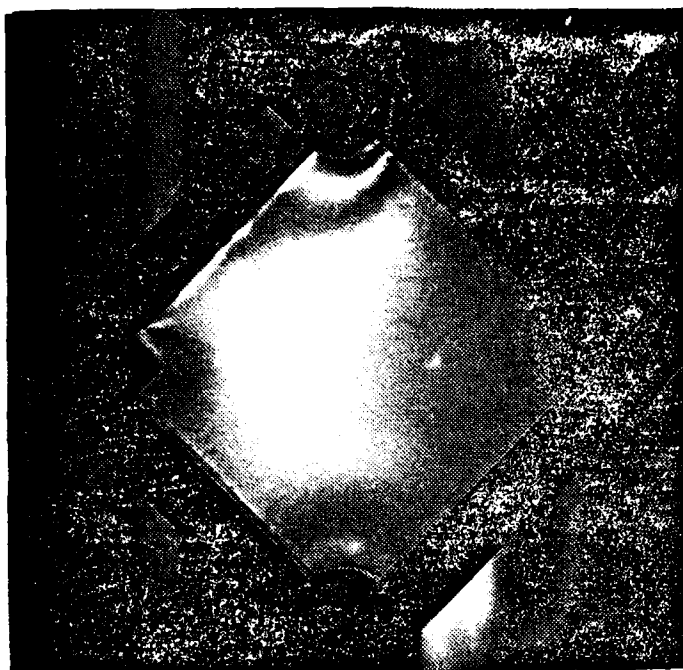
photographic results of the stress distribution throughout the load cycle. It can be seen from these results that uniformity of stress in fact did exist across nearly the entire test area at higher loads, with the stress gradients being restricted to the regions immediately surrounding the corners and near the edges.

This appendix contains photographs of a test panel constructed of photoelastic material and loaded incrementally until failure. The process used for taking the photographs was a reflective process. A polarized light was shown against the panel, which had been coated on the opposite side with reflective aluminized paint. The reflected light was photographed through a polariscope, as depicted below. The results for successive loads are shown in the following pages.
